Non-Intrusive Inspection of Buried Pipelines

Guided Wave Technology

-   **Client**
Oil & Gas Operator
-   **Location**
Refinery, UK
-   **HSEQ**
No loss of time incidents

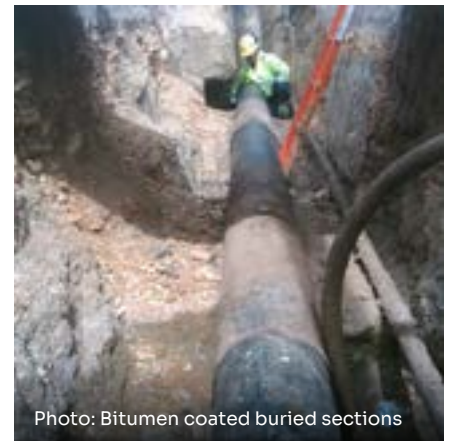
Photo: Bitumen coated buried sections

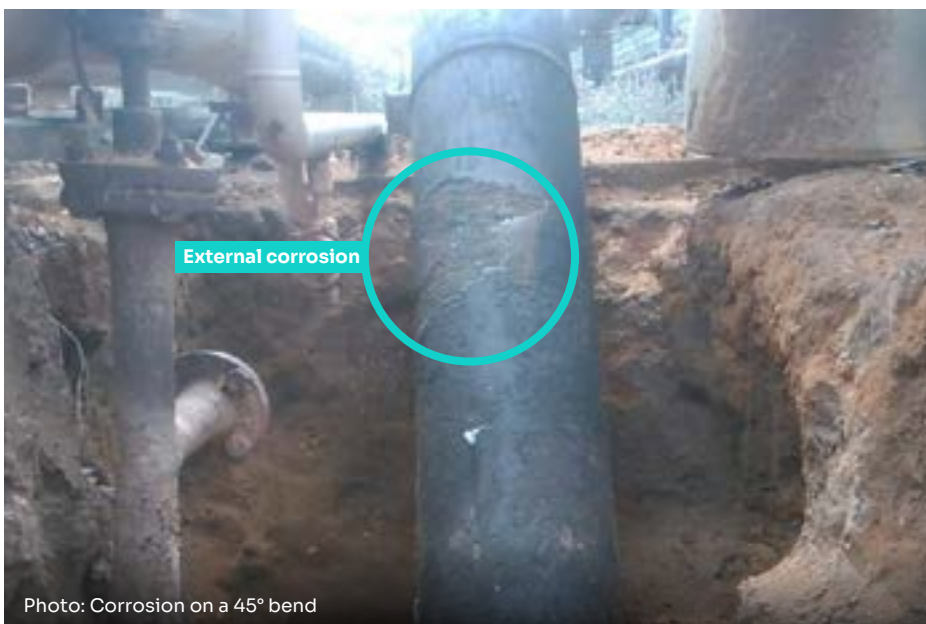
Photo: Corrosion on a 45° bend

Our trained inspectors analysed the data and highlighted an area of concern further down the pipeline. An excavation at this location confirmed significant external corrosion, which we were able to quantify with more accurate methods such as phased array ultrasonics. This enabled the client to take corrective action with minimal disruption.

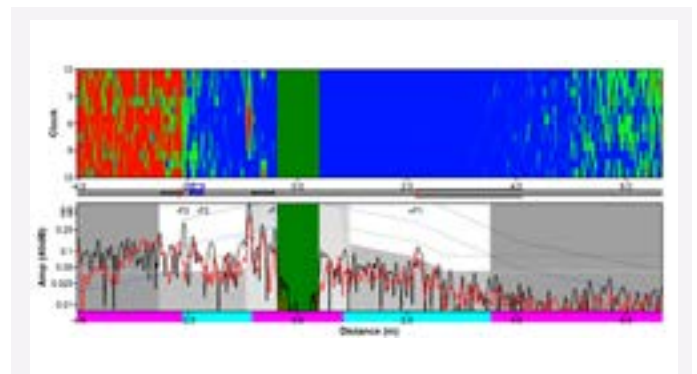
From a single excavation point, our team were able to inspect extensive sections of the pipeline for changes in a cross-sectional area that could indicate corrosion or other damage. This initial screening successfully identified an area of concern.

Photo: Data analysis indicating potential corrosion

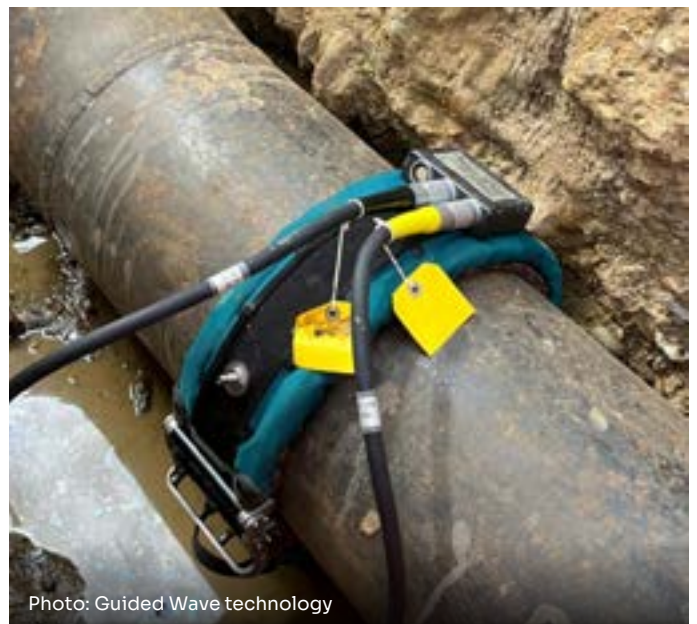
To overcome these challenges, we implemented Guided Wave technology, a non-intrusive method for inspecting pipelines. This technique uses low-frequency torsional waves transmitted along the pipe wall from a single location. Under suitable conditions, Guided Wave can screen up to 230 metres from a single access point. The results highlight potential defects, which can then be confirmed using follow-up methods such as ultrasonic testing (UT), phased array ultrasonic testing (PAUT) or radiography.

Photo: Guided Wave technology
